## Avro Anson Project

Project planning began in the spring of 2022. Our overall goal at the end of the project is to have a restored Mark I Avro Anson in taxi condition. This means a non-flying aircraft with operational engines and systems representing the Anson trainers that flew in Saskatchewan as part of the British Commonwealth Air Training Program (BCATP) during the Second World War.

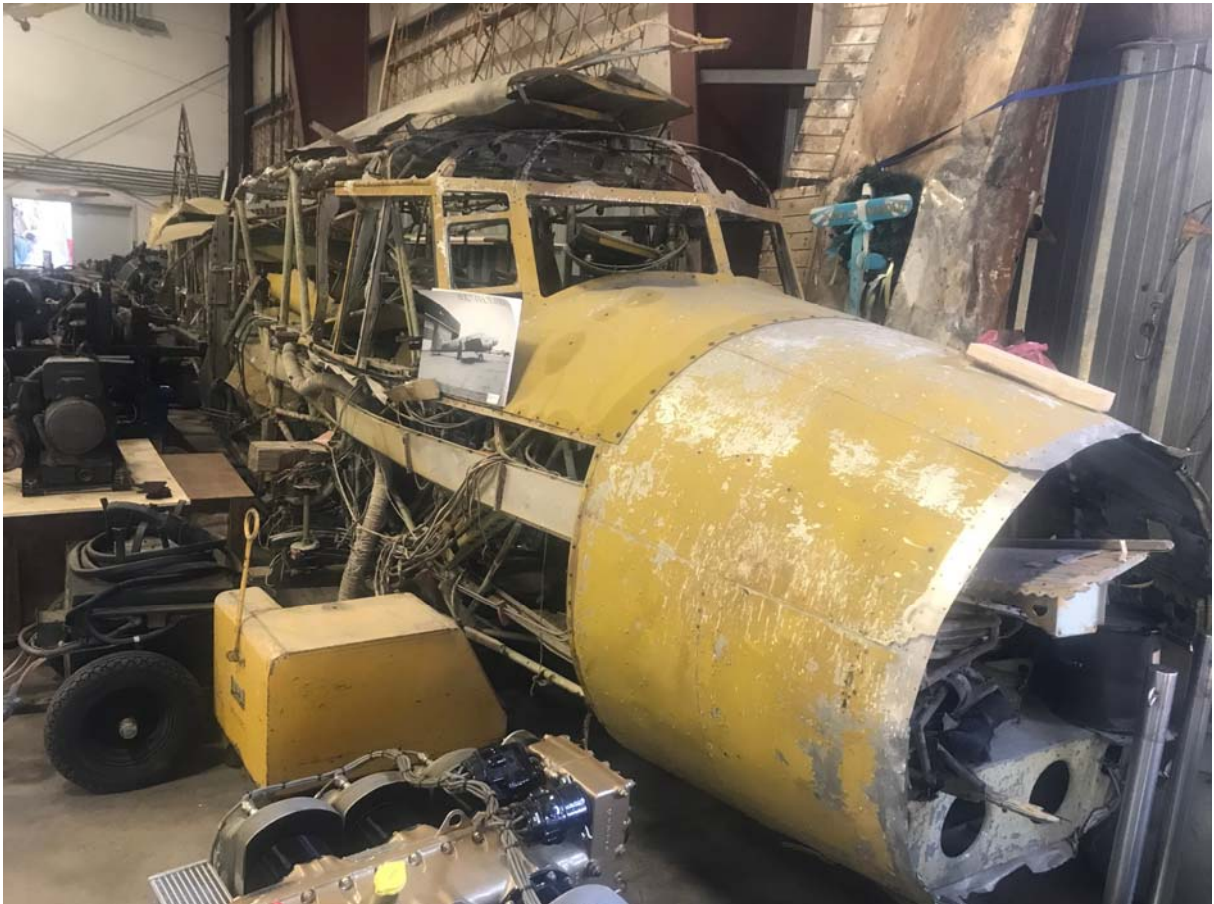
The first task (on a VERY long list of tasks) is to inventory the many parts that came with the Anson. In addition to an airframe crammed full of parts:

*Airframe + parts*

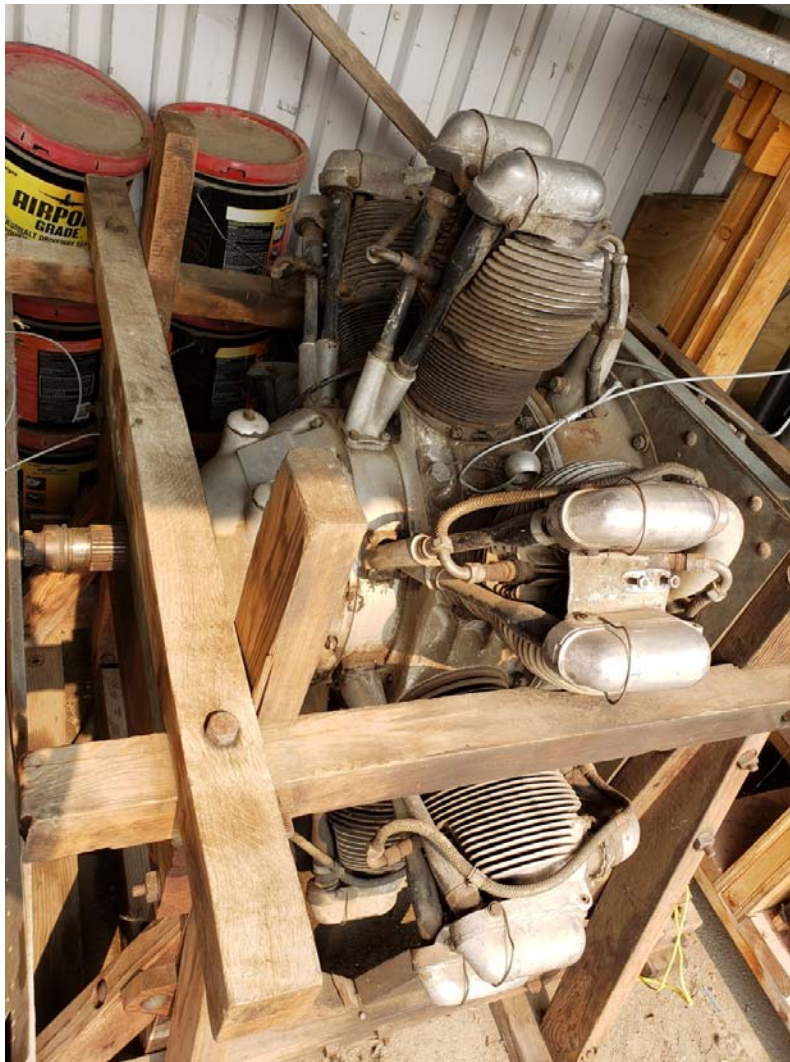
there are four Armstrong-Siddeley Cheetah Mk IX engines, one of which is still mounted in its shipping frame and is rumoured to be a zero hour engine:

*New-in-box Cheetah IX?*

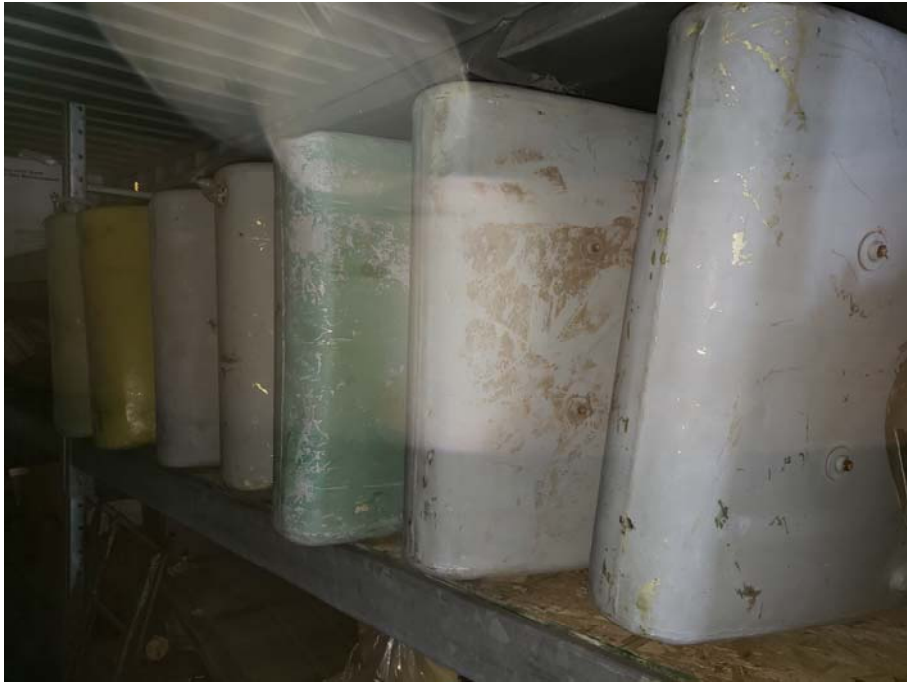
*Fuel tanks*

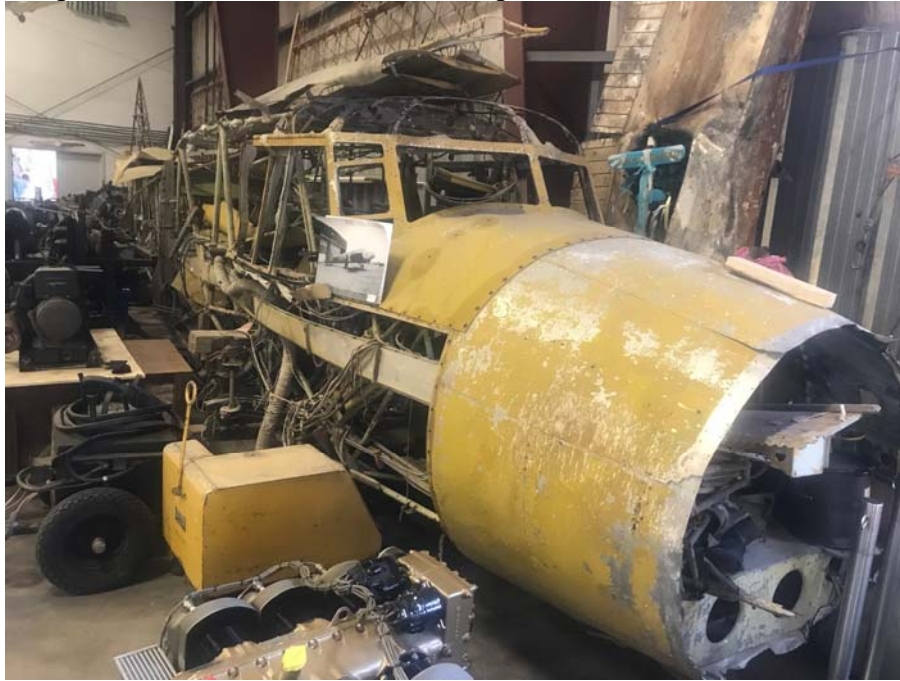
**July 2022** – When the Anson was brought into the museum a lot of unattached parts were crammed into, under and on top of the airframe as there was no space to store them.

*Airframe full o' parts*

Obviously before any work can be done on either the airframe or these parts they will need to be removed, catalogued and stored somewhere. Fortunately there is some underutilized space in a loft above the hanger offices. We start with the aluminum panels; for a supposedly “stick and fabric” airplane the Anson has an amazingly large amount of sheet metal.

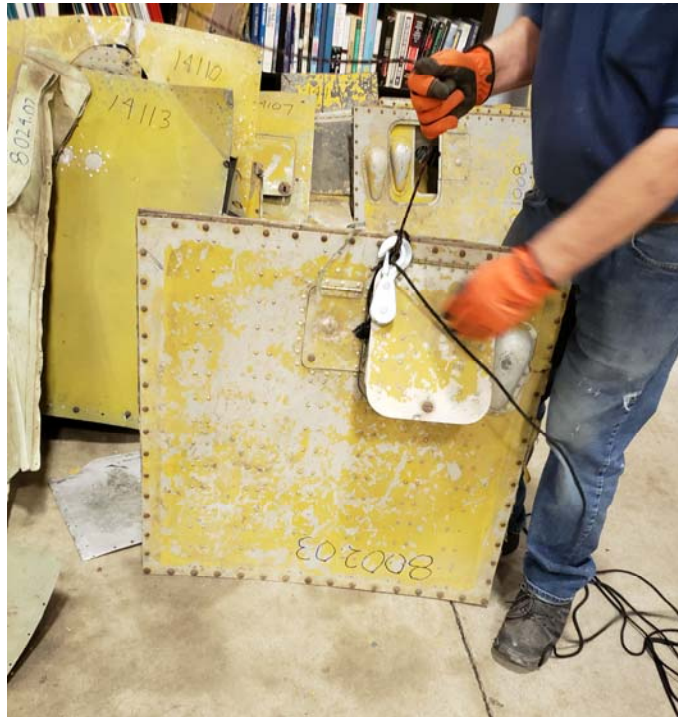
*A fuel tank cover panel ready to be winched up to the hanger storage loft*

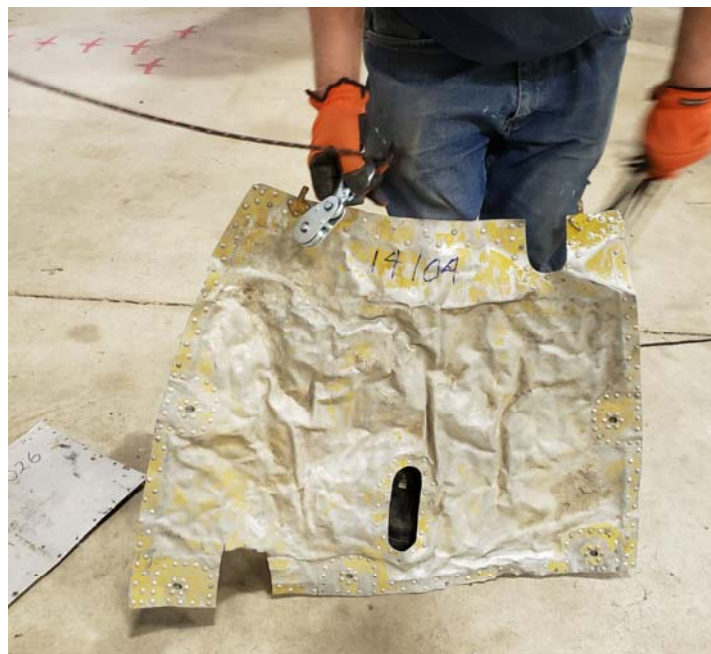
Not all the sheet aluminum is in pristine condition. Looks like somebody was using this engine cowl for step dance practice. Fortunately we have duplicates:

*Damaged cowl*

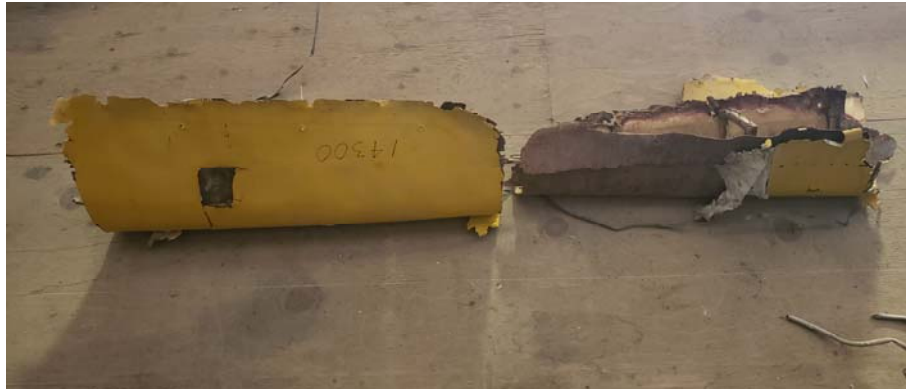
Even badly damaged pieces are kept for use as patterns or as reference. For instance, this weathered fragment of wing leading edge may not look like much:

*Wing fragment*

But it reveals a great many important construction details, including how the laminates of the rib flanges are fabricated, how reinforcement blocks and stringers fit together through the rib, the location and fit of the hole reinforcement pieces, attachment of the bonding (the electrical ground strap) and even the location of the vent eyelets for relieving the pressure differential between inside and outside the wing.

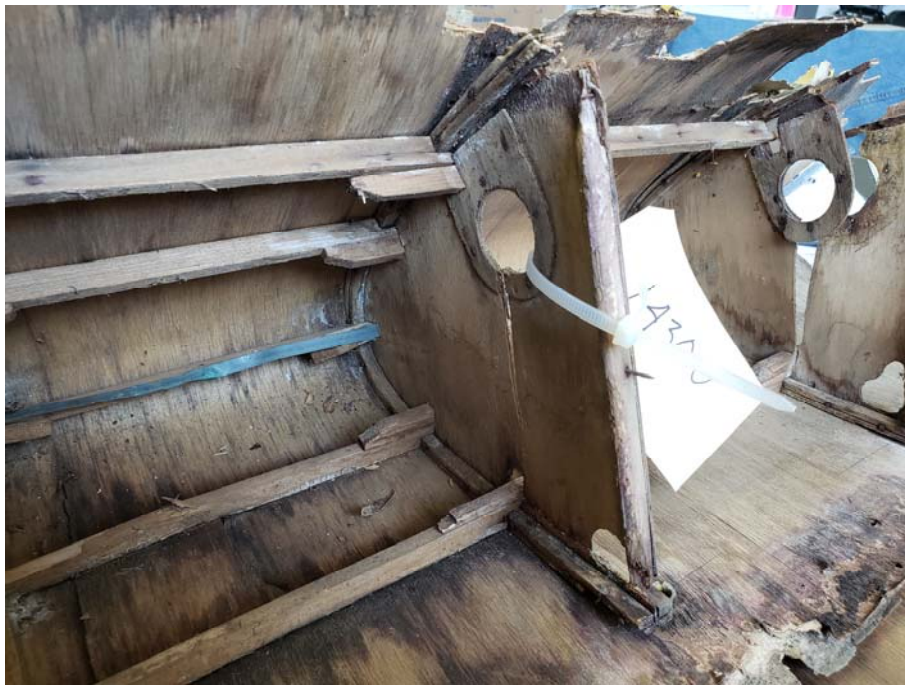
*Wing fragment interior*

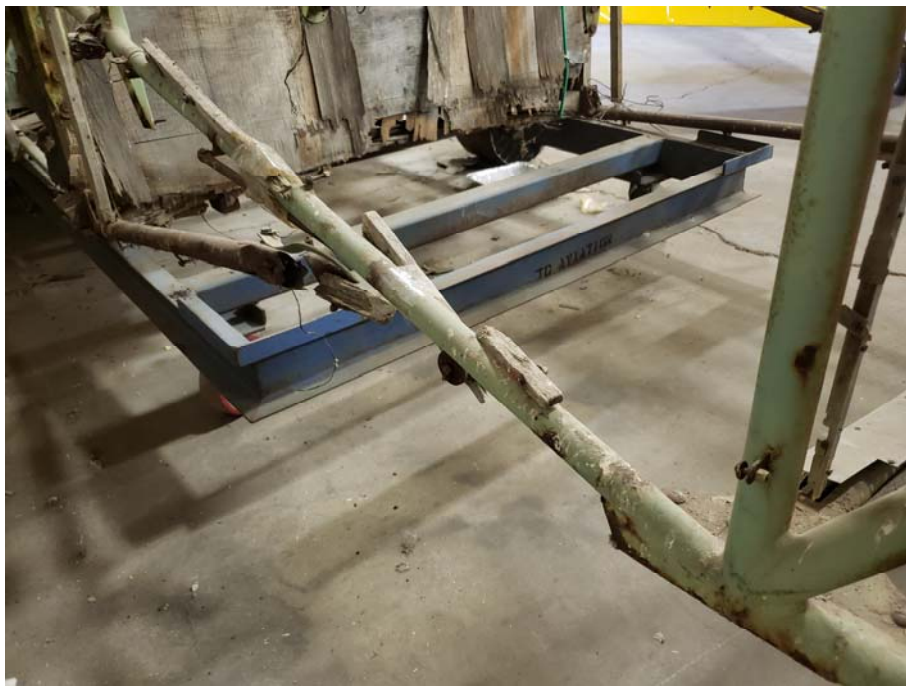
Spend the next couple of weeks cleaning many kilos of bird droppings out of the airframe – for several years prior to our acquisition it was stored in a hay shed where hundreds of swallows nested. Inspection of the frame finds the only major damage is a broken frame tube just behind the rear wing spar:

Frame damage

Included in our spares is the rear part of an airframe (cut off behind the wings). We cut out the section of tubing needed to replace the damaged part on our frame (see August post) plus some lengths of spare tubing (never know when you might need a frame tube) and strip the remainder of any usable brackets, clips and pulleys.

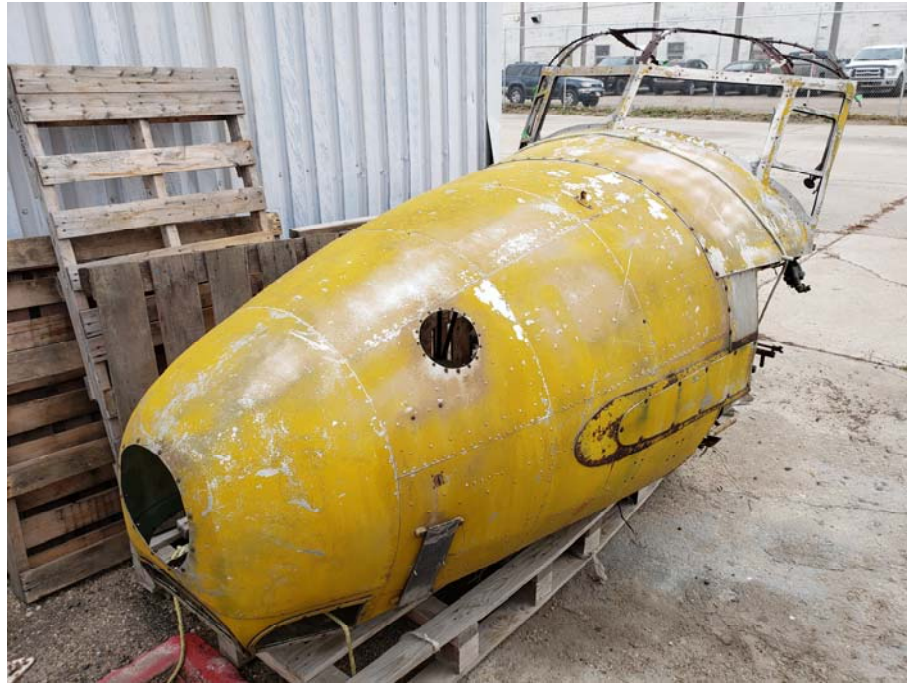
We also have a spare nose that is in better shape than the one currently in place, so that too will get stripped for painting prior to replacing the existing nose.

*Replacement nose section*

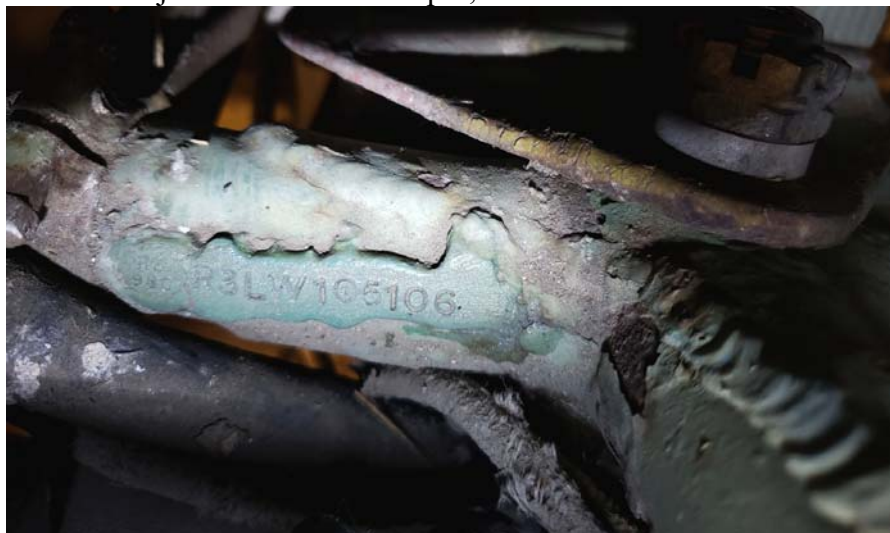
While cleaning the airframe we discover the manufacturer's serial number stamped into a solder plate on the right hand frame tube just above the front spar; a clue in the search for our Anson's true identity:

*Airframe serial number*

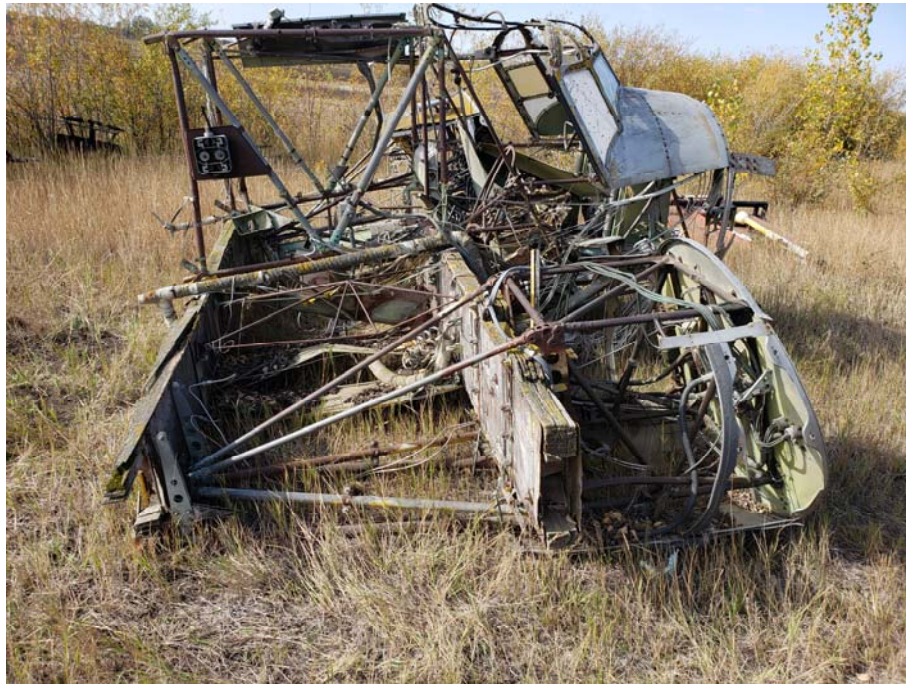
**October 2022** – We move some large pieces in outside storage (unfortunately our limited hanger space doesn't let us keep everything inside). This fuselage centre section is from a Mk V Anson but still has many cockpit, wing and engine nacelle parts we can use:

*Spare centre section*

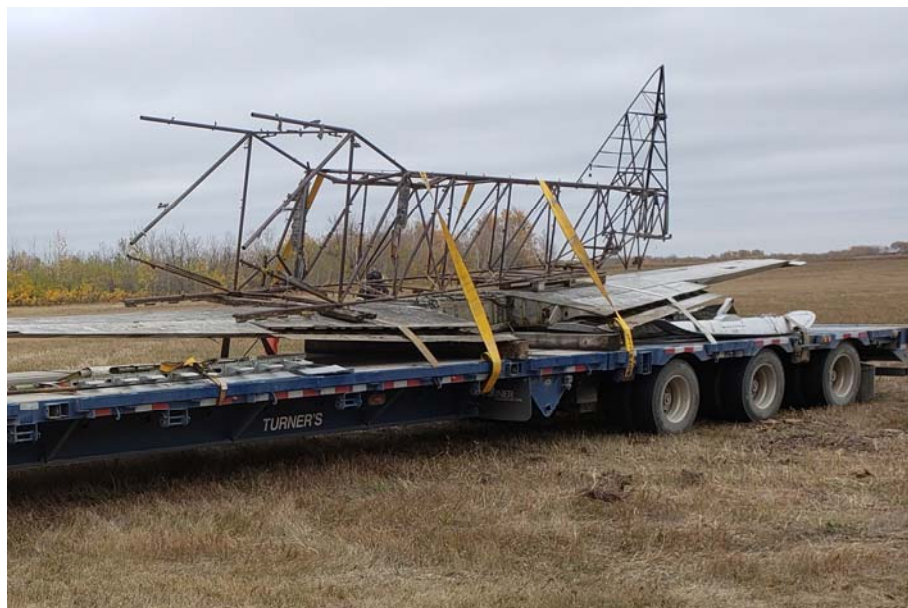
*Partial airframe (that's a T-33 wing under the frame – spares for another plane at the museum)*

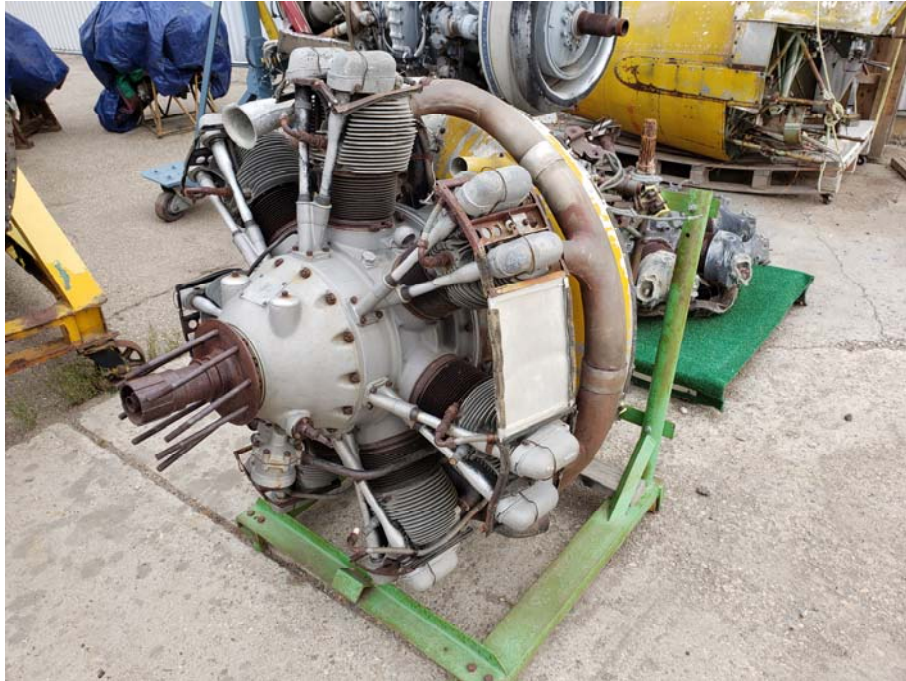
*Armstrong Siddeley Cheetah engine*

Winter is coming; the engines get wrapped in tarp and will go under a covered awning adjacent to the hanger. Hope to work next spring toward getting these in running condition.

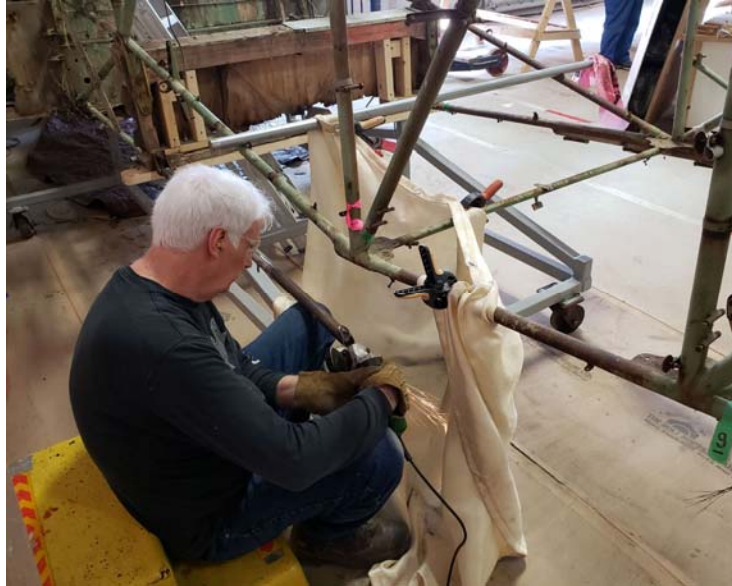
*Frame tube replacement*

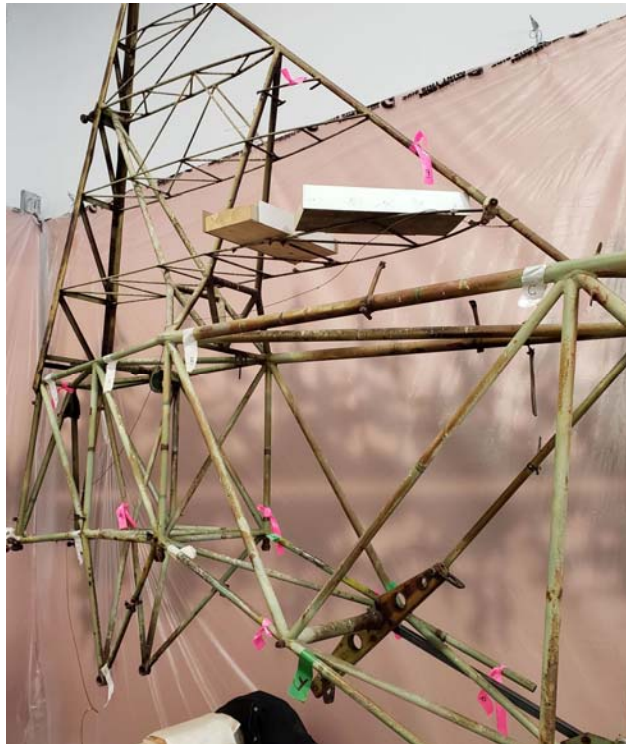
Of course as we start taking pieces off we get a closer look at the frame members and discover a number of additional spots that will need repair – not unexpected. Each of those pink ribbons is a location that will require a welded repair:

*Repair weld spots*

Most of the repairs are pretty minor, mainly attachment tabs for formers that have been broken off, but a few tubes have corroded through or been cut out years ago for duty on a farm somewhere.

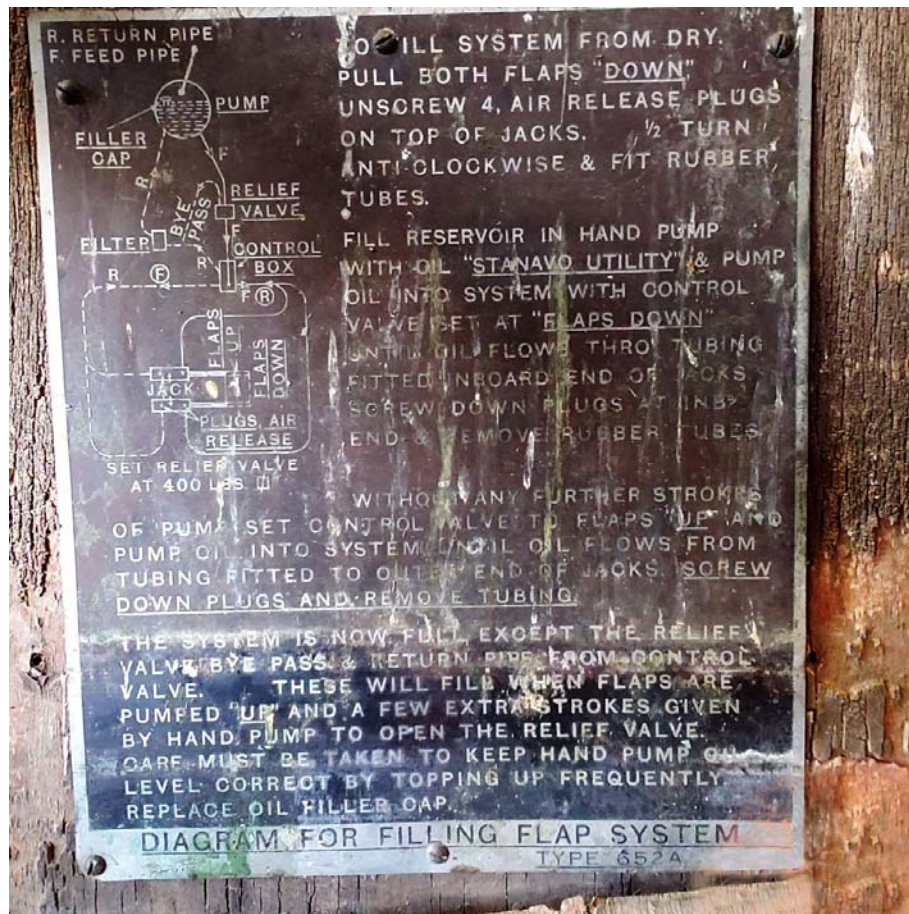
Always making fun little discoveries as we strip and clean. Here's a plate attached to the main spar with directions for priming the manual hydraulic system that raised and lowered the flaps:

*Priming instructions for the hydraulic system*

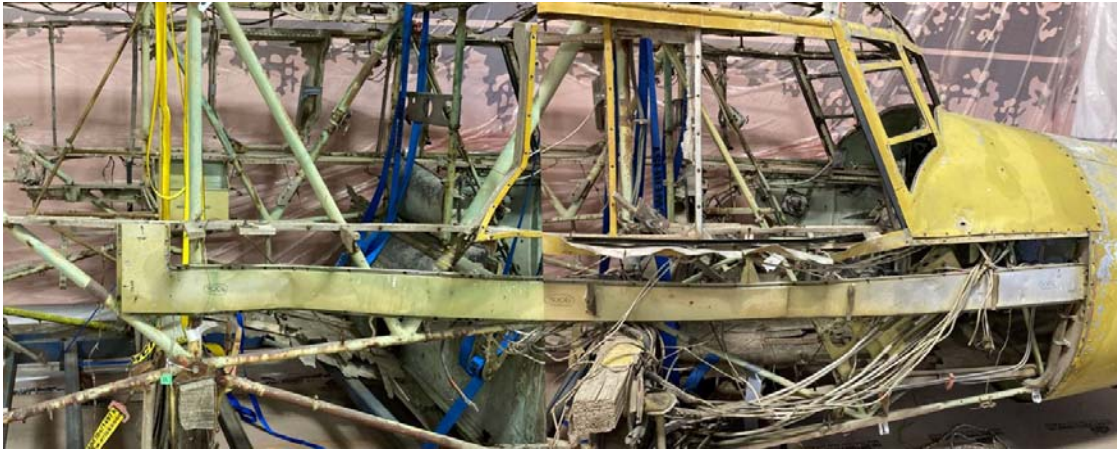
Here's a shot of the main cable tray situated on the right side of the cabin (with lots of cables and wires hanging around it). Most of the wiring between the cockpit controls and the electrical panel at the back of the cabin is routed along this tray.

*Main cable tray*

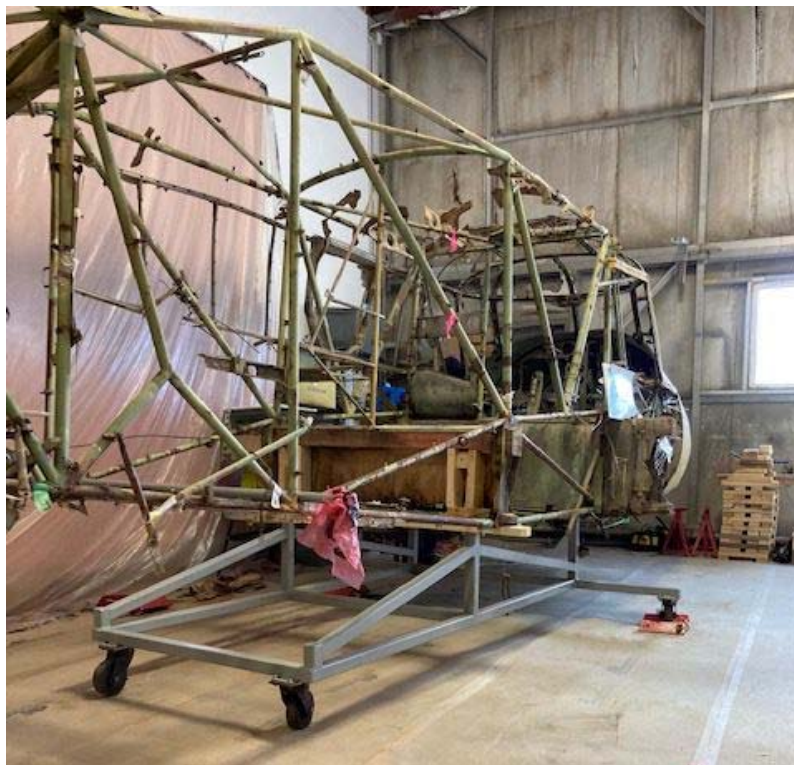
The big news is that the airframe is now mounted on its new cart, design and fabrication by Greg at Brandt Engineered Products, thanks Greg!

*New airframe cart*

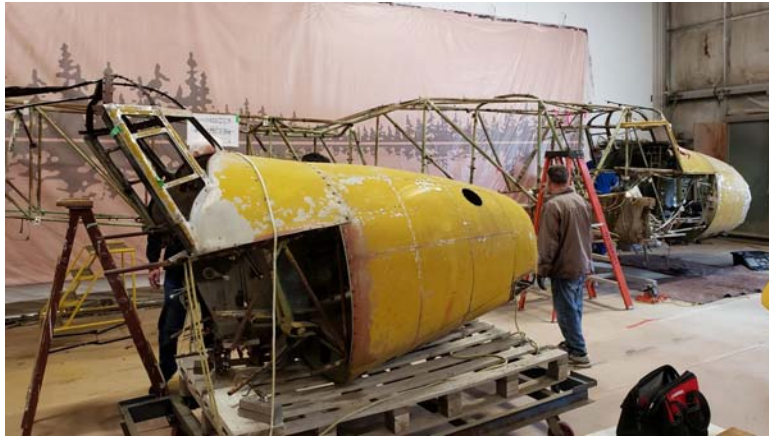
**May 2023** – Frame tubes are repaired and ready for welding in place. The replacement nose has been moved into the hanger and we have begun removing parts:

*Replacement nose*

The aluminum/Elektron skin is in quite good shape. But, oh man! Those hundreds of tiny, tiny nuts and slot head screws (Number 6 British Associated) in the window framing to hold all the glazing in place! They look fairly corroded (as one would expect from decades out in the elements), but amazingly most come apart with little fuss.

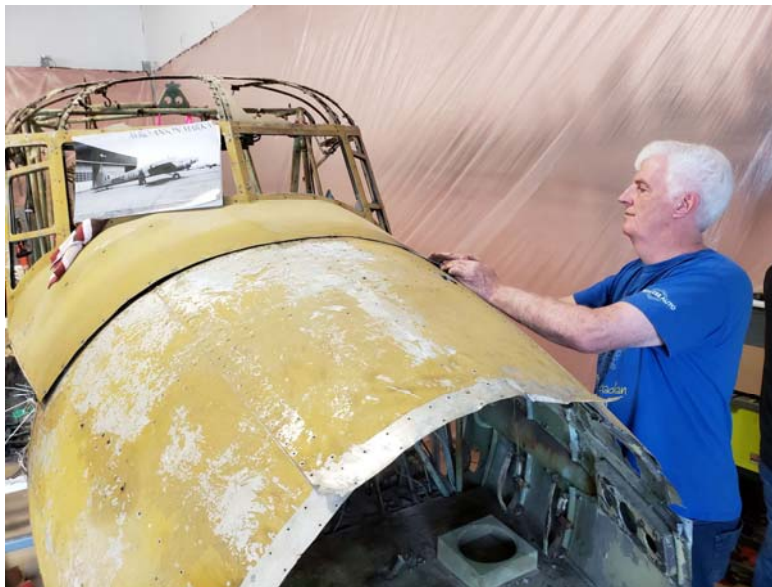
The front panels of the existing nose are just about ready to be removed:

*Damaged nose coming off*

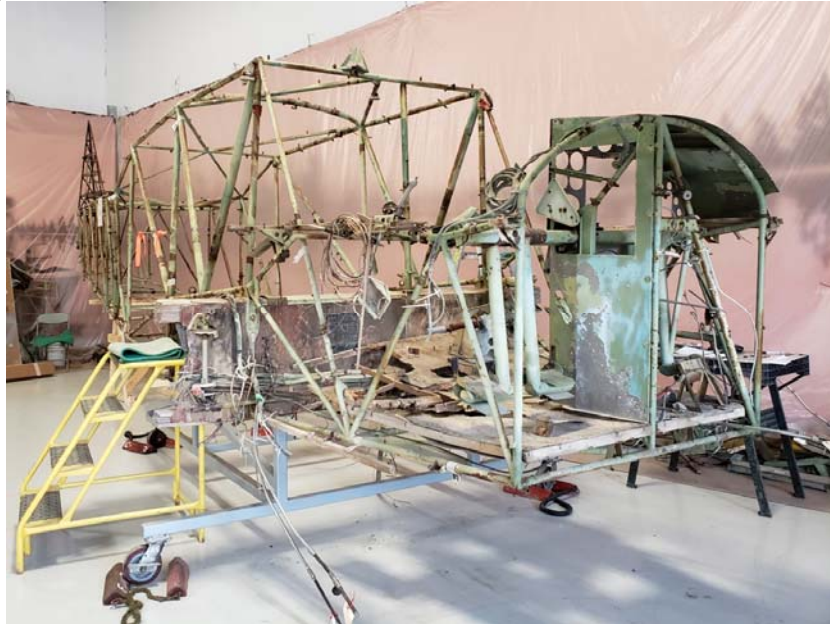
**June-July 2023** – Stripping the frame continues, working on the instrument panels, control columns and the equipment under the cockpit floor. Just the cockpit floor itself, a bit of wiring, some brackets and the rudder controls to remove now:

*Airframe nearly stripped*

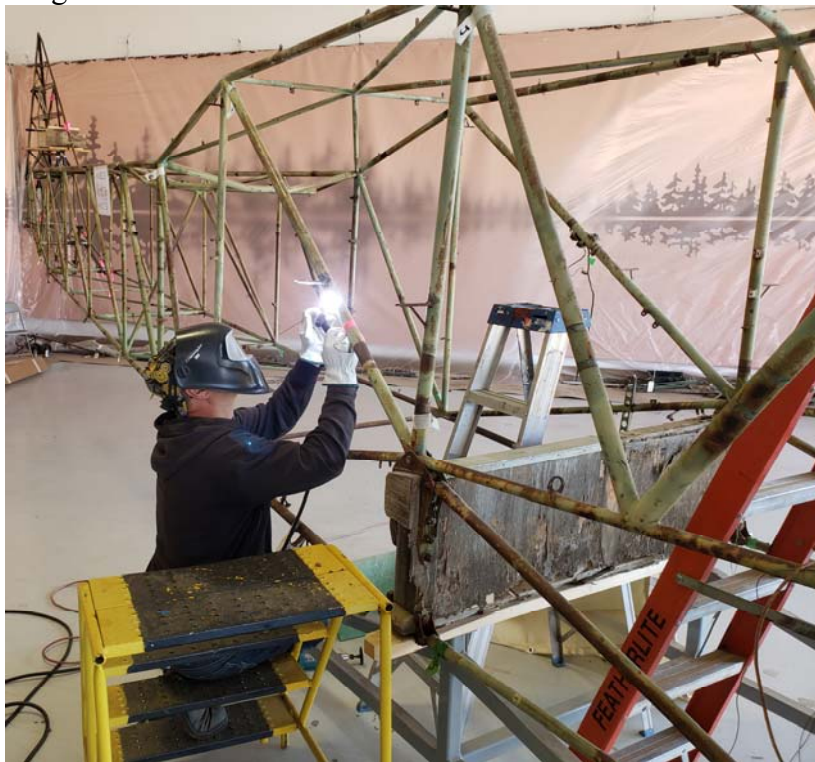
*Welding a new shelf bracket in place*

Welding repairs get done in June:

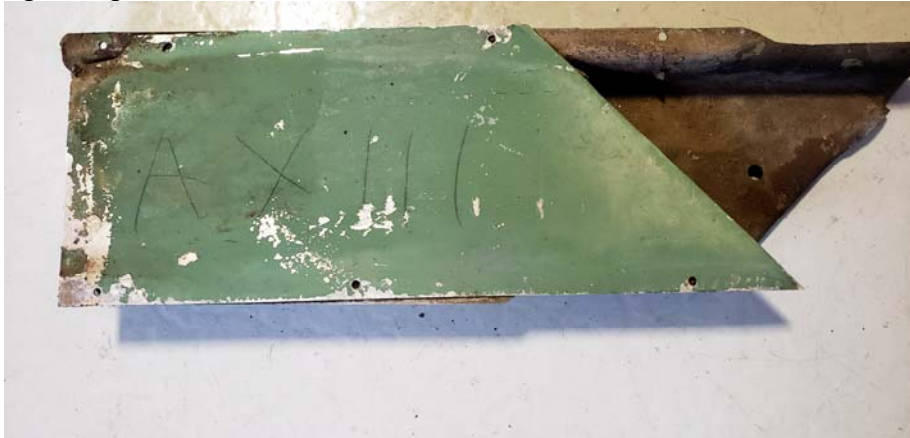
BIG NEWS!!! The true identity of our Anson has been discovered! From the airframe serial number and records from the Avro Heritage Museum, we knew our aircraft was from a production block of four delivered to the RCAF: AX110, AX111, AX114, AX116, and that it was most likely AX111 or AX116 as these two had been sold from dispersals in southern Saskatchewan. From the amount of wear and some nose damage it seemed that AX116 was the most likely candidate. But in early July when the cover for the landing gear chain was removed from the underside of the cockpit floor, we found marked in grease pencil: **AX111**:

*AX111*

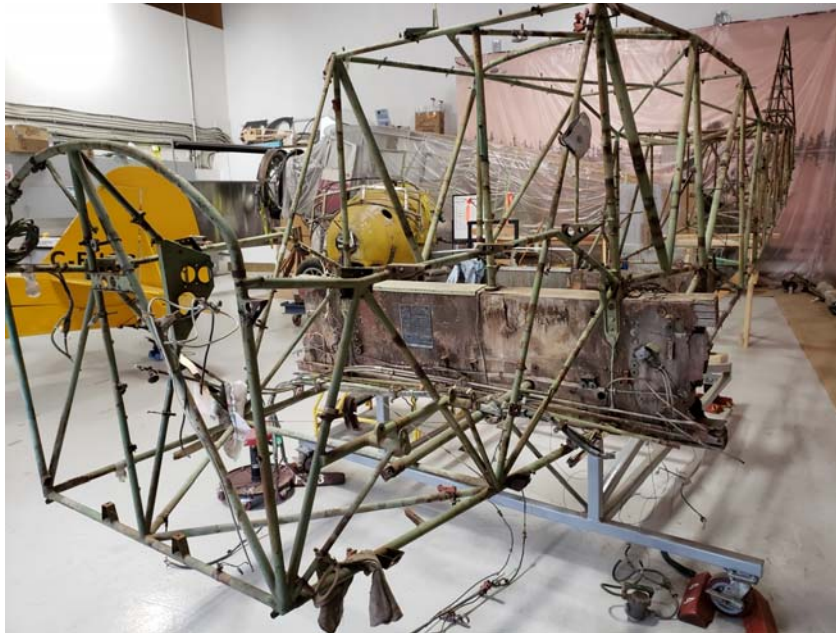
By mid July all the major pieces are out, just cleanup now before we can begin prep for painting:

*Stripped airframe*

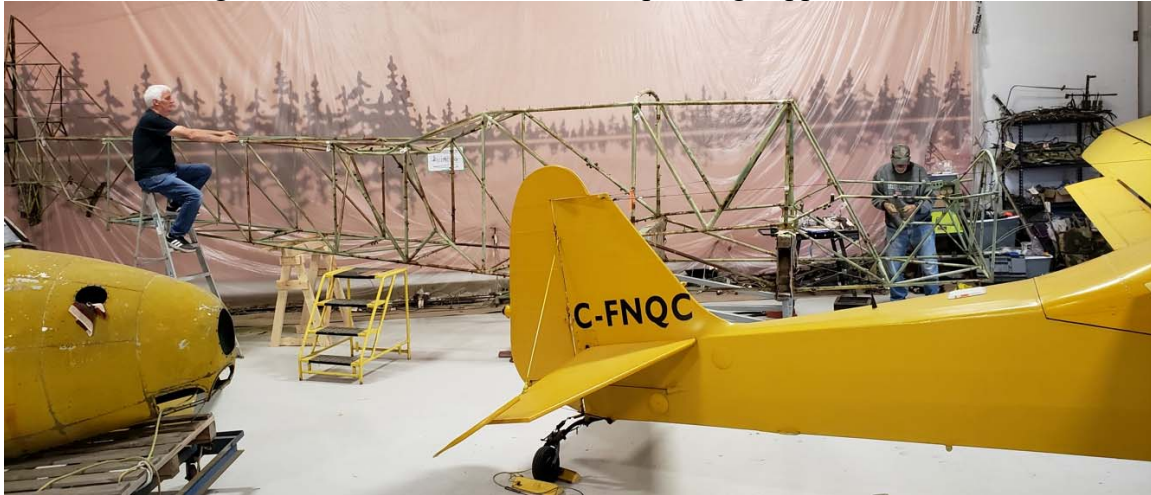
**August 2022** – A milestone, the last piece is disassembled from the airframe (the undercarriage crank on next to the pilot's seat). It's all uphill from here ☺! Sanding the bare airframe begins. Another month or two until painting happens?

*Sanding the airframe*

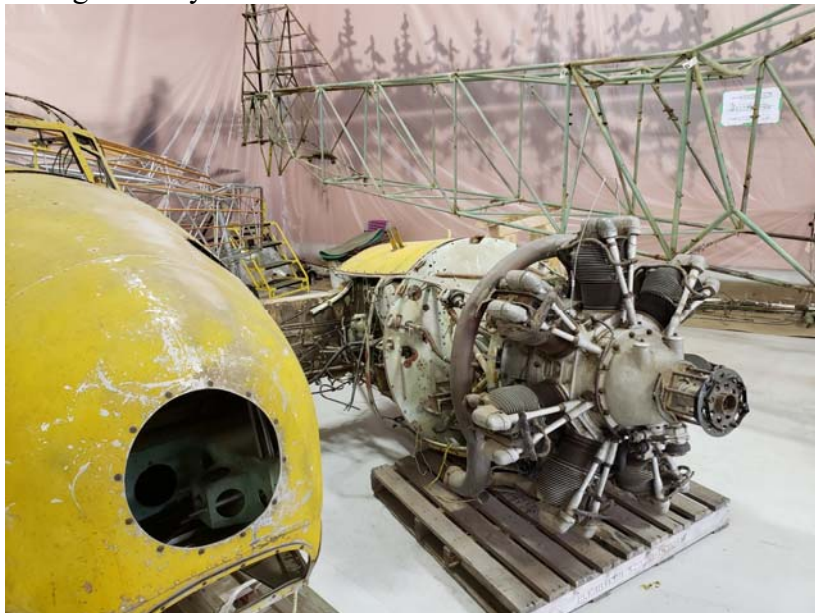
The Cheetah engine in its nacelle gets moved into the hanger so we can clean it up and begin planning engine work. In my spare time I start reading up on aircraft magnetos; quickly come to the realization that their operation is comprised of roughly equal parts blacksmithing, Voodoo and quantum mechanics! Head hurts, back to sanding frame tubes. Whole new respect for the amazing inventors who dreamt up the incredibly complex operation of these devices in the late 1800s, long before computers, oscilloscopes or signal analyzers.

*Cheetah Mk IX and nacelle*
